Learning from the Piper Alpha Accident: A Postmortem Analysis of Technical and Organizational Factors

M. Elisabeth Paté-Cornell¹

(Received September 18, 1992; revised October 22, 1992)

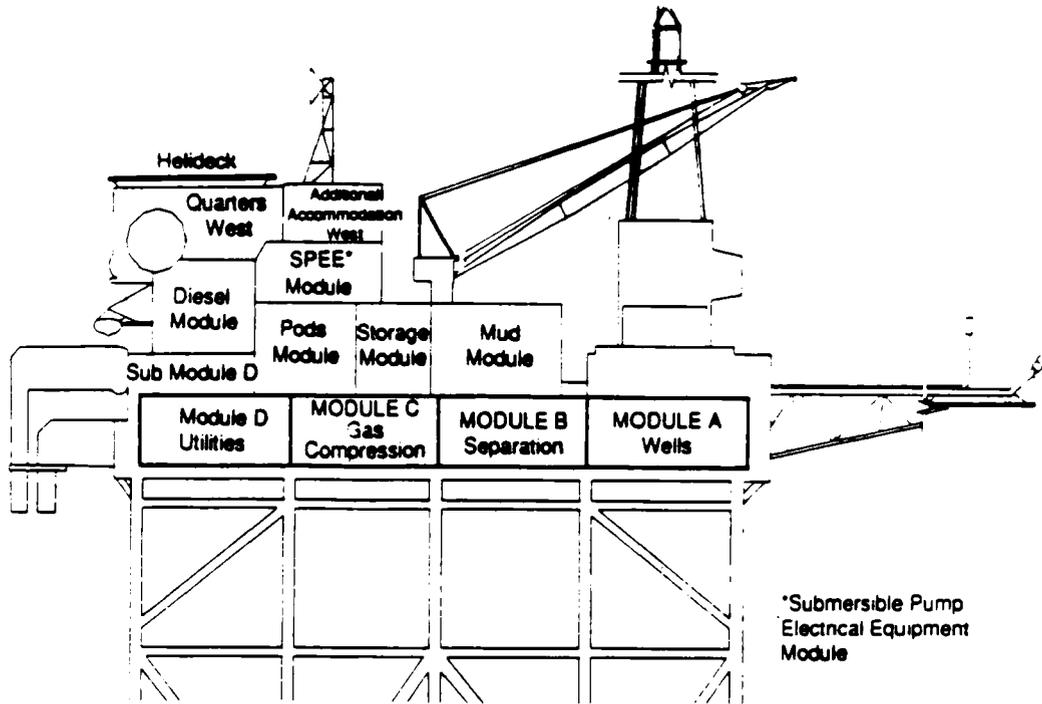
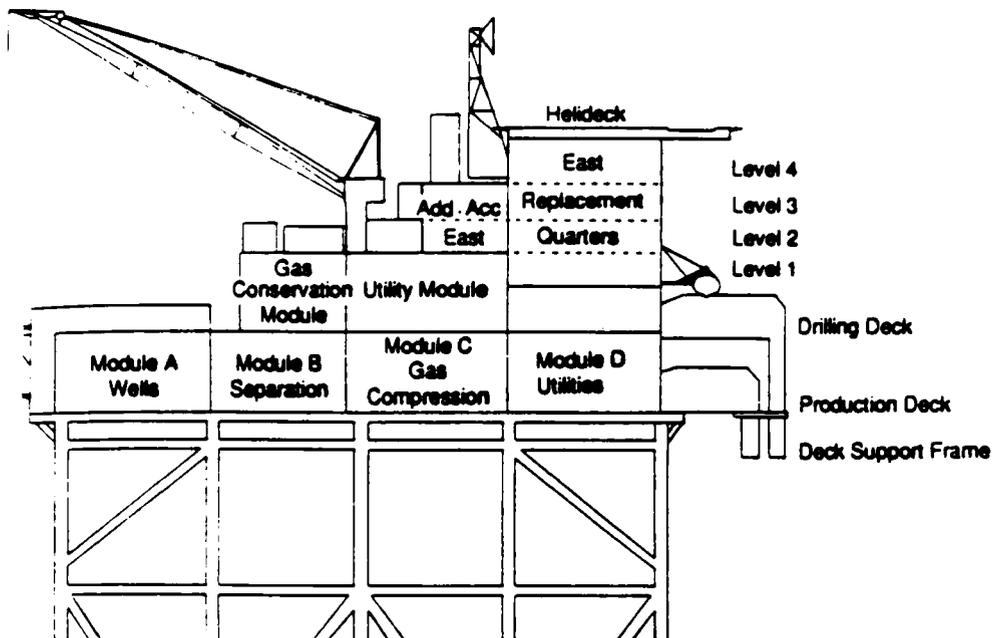
Fig. 2. The layout of Piper Alpha.⁽¹⁾

Fire walls and blast walls have different characteristics, and blast walls may cause new problems by creating projectiles if and when they finally break. However, fire and blast containment systems on board Piper Alpha were generally insufficient (Ref. 1, 66; Ref. 2, 9.4.15). In particular, the blowout (side) panels were ineffective.

The location of the radio room on the east side of the platform (AAE) above the C module made it vulnerable to production accidents. Given the interdependencies among the different platforms in case of emergency, and the assumption that the OIM on Piper Alpha was to assume the role of on-scene commander (OSC) for the rescue, the loss of the radio room prevented critical exchanges of information with Tartan, Claymore, and the vessels in the vicinity (decapitation of all damage control operations).

First, the location of the control centers and utility modules close to the production modules caused the immediate death of a certain number of key operators and personnel. Second, the poor location of living accommodations too close to the production modules and equipment allowed the smoke to fill the quarters and failed to provide a safe temporary refuge for the personnel. Third, the poor planning of the exits (lack of separation, redundancies, and single-point passages) led to the early blockage of the planned evacuation routes and the ina-

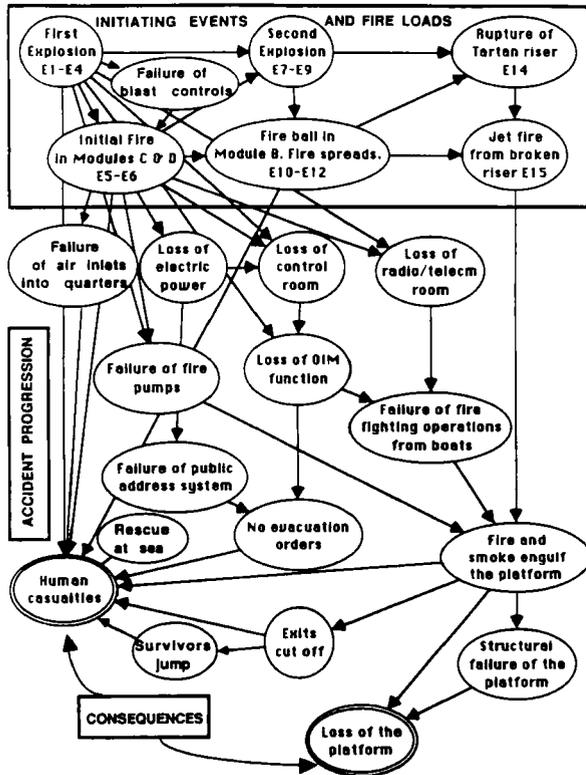
Fig. 3. Event dependencies in the Piper Alpha accident scenario (influence diagram representation).⁽⁴⁾

and the dependencies among them are presented in the influence diagram of Fig. 3. This *post facto* failure mode identification excludes secondary events that may have promoted the basic events but are not part of the failure

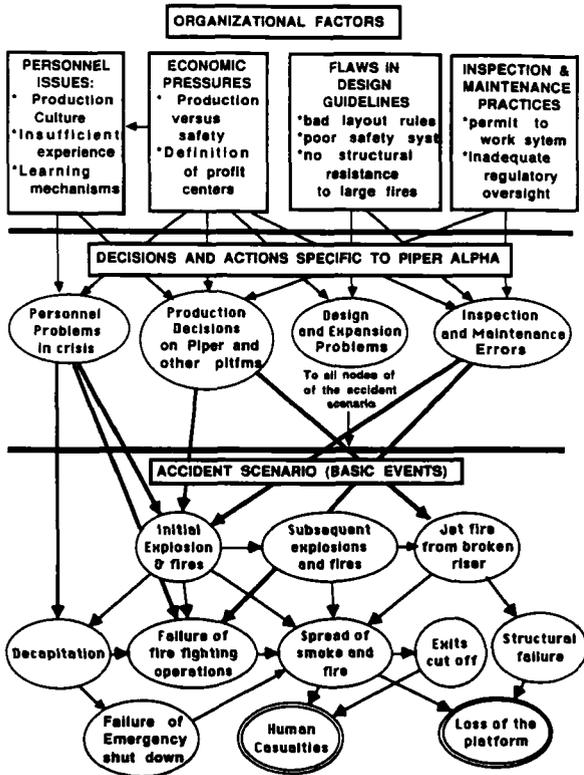
Fig. 4. Dependencies among basic events of the accident scenarios, decisions, and actions specific to Piper Alpha, and organizational factors (influence diagram representation; the lower part is a simplified version of Fig. 3).⁽⁴⁾

Key organizational factors that are at the root of the decisions identified in the previous section are the following: (1) questionable judgment in the management of productivity vs. safety; (2) flaws in the design philosophy and the design guidelines; (3) problems of personnel management; and (4) insufficient attention to maintenance and inspection (see Fig. 4). All of these involve questions of information (Do the personnel have appropriate levels of knowledge? Do they receive appropriate information to take action in different cases?), incentives and rewards (What are people actually told to do? If they don't do it, what are the consequences for them? What are they actually rewarded for?), and resource constraints (time, money, and attention). As a result, problems accumulated, generated by an organizational structure that lacked redundancies, procedures that allowed cutting corners, and a culture that encouraged flirting with disaster.⁵ Once again, the conditions described here may not have existed in July 1988 in other
